Hoonah Bluffs Stabilization

Site Assessment

June 2017

Prepared By PND Engineers Inc.

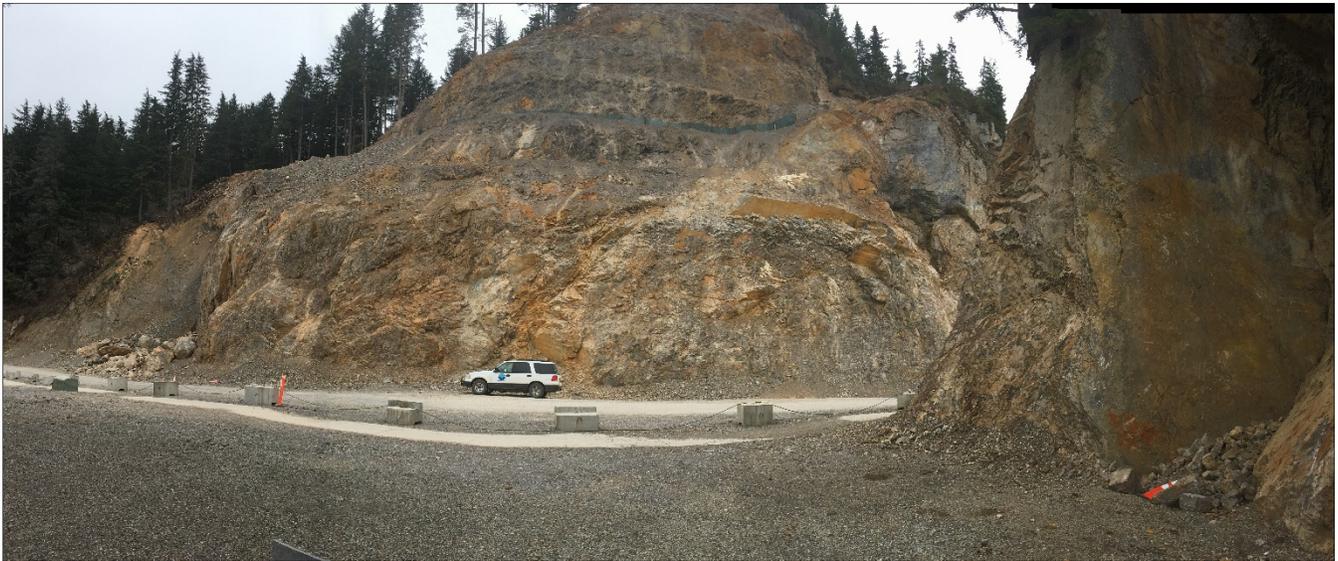
Figure 1 shows a panoramic view of the Hoonah Bluffs, while Figure 2 shows the bluffs divided into sections for characterization and discussion purposes. Section 1A, Figure 2 shows the initial slope failure created by blasting operations that initiated the April 26 site visit. Detailed descriptions of the failure slope and other nuisance failures are provided in following sections.

Figure 1. Panoramic View of the Hoonah Bluffs with Rock Slope Failure (viewers left)

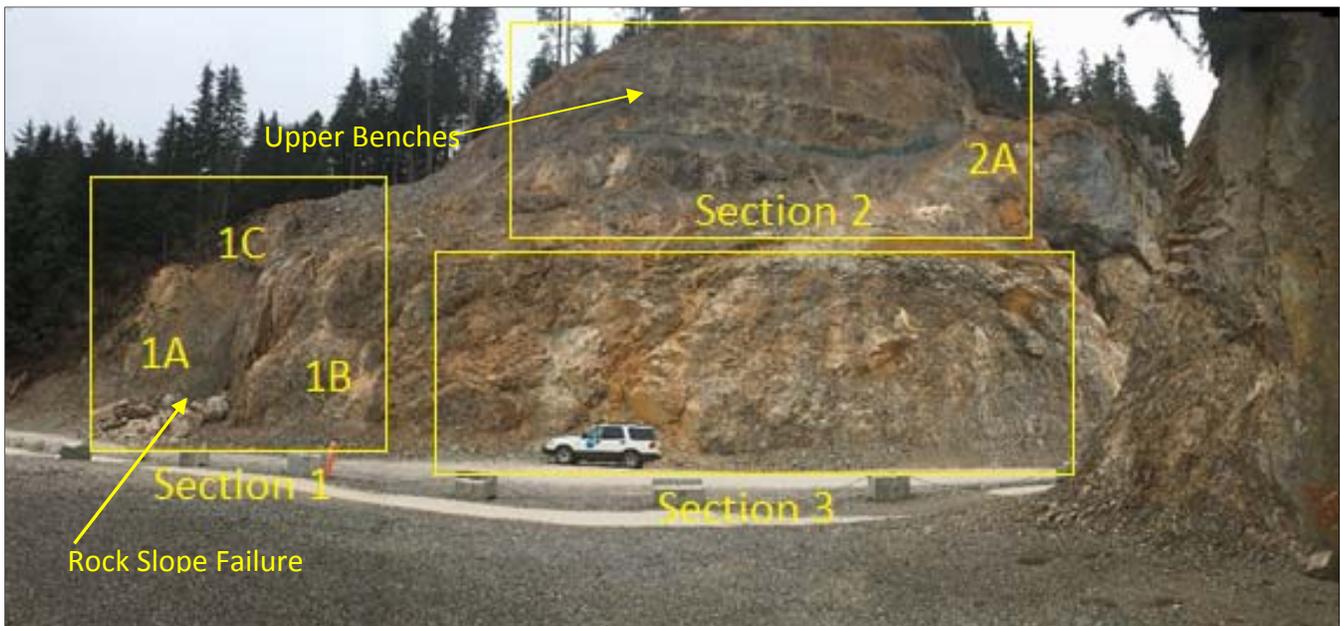
Figure 2. Hoonah Bluffs Separated into Sections

The rock slope failure (Figure 2, Section 1A) was a wedge and toppling failure primarily due to uncontrolled blasting energy or a powder factor too large for the geological conditions. Excess energy separated the daylighted limestone rock mass wedge into approximately three-foot to five-foot thick vertical shives that rested on the interbedded argillite-greywacke layer beneath. The wedge trough dips at approximately 40° and 60°. The remaining rock mass that had not failed, but subsequently partially failed on May 8, 2017 (Figure 5, Figure 6) shows the development of vertical shives/slivers developed by overbreak and the heaved rock mass at the discontinuity interface (Figure 6).

- the lower rock face in Figure 2, Section 3 appears undisturbed and will likely remain stable

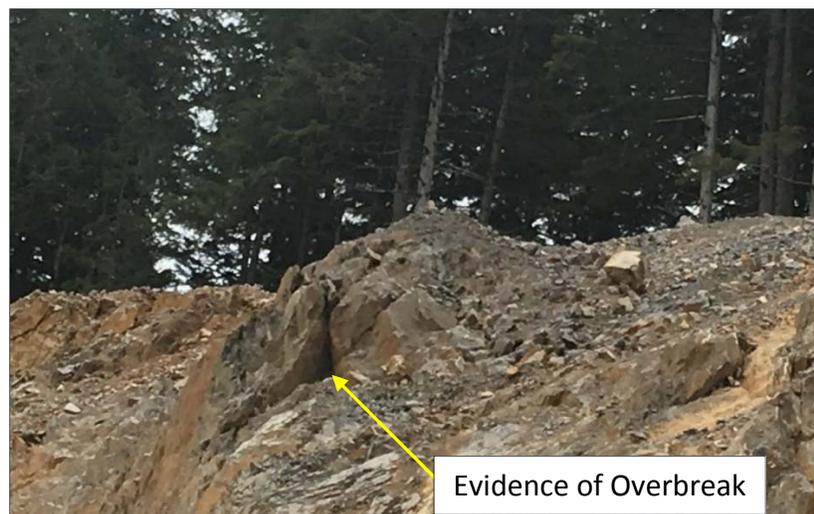
Controlled blasting methods are used to greatly minimize overbreak/backbreak of the rock face beyond the design neat line of excavation. Overbreak is disturbed rock: rock that has been disturbed and fractured but remained in place after shot material has been excavated. Overbreak can be seen as tight fracture lines or fractures with considerable separation (heave) between rock blocks. Overbreak and/or excessive energy and high powder ratio (pounds of explosive per bank cubic yard), in addition to poor blast design, can also cause the heave/separation or disturbance of natural discontinuities and joints between rock blocks. The discontinuity may have been stable prior to blast disturbance, however uncontrolled blast energy moved or heaved the rock masses such that the discontinuity aperture had greatly increased after blasting. Separation of the rock masses at the discontinuity destabilizes the rock masses and reduces the friction or bonding infill that holds the rock masses in place. Figure 3 shows an example of overbreak, however evidence of overbreak can be seen over the entire surface of the project backwall/as-built neatline. Not evident in the photos presented, but observed in the field with binoculars, is the overbreak in the backwalls of the upper benches (Figure 2, Section 2).

Figure 3. Overbreak

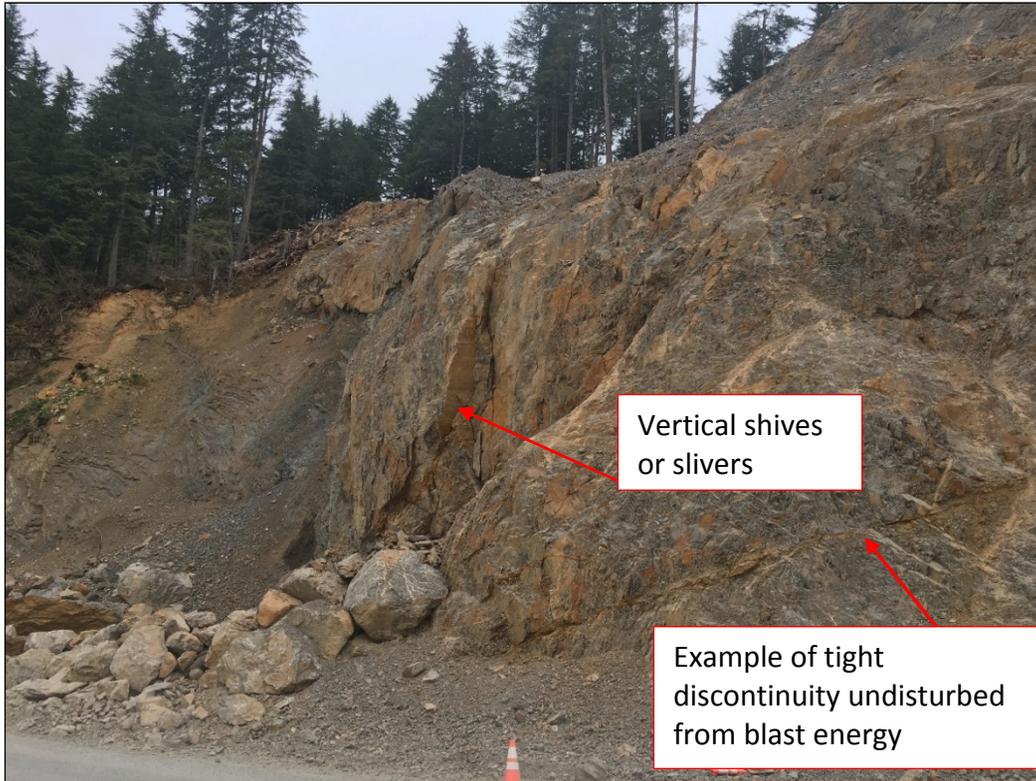
Figure 5. Overbreak

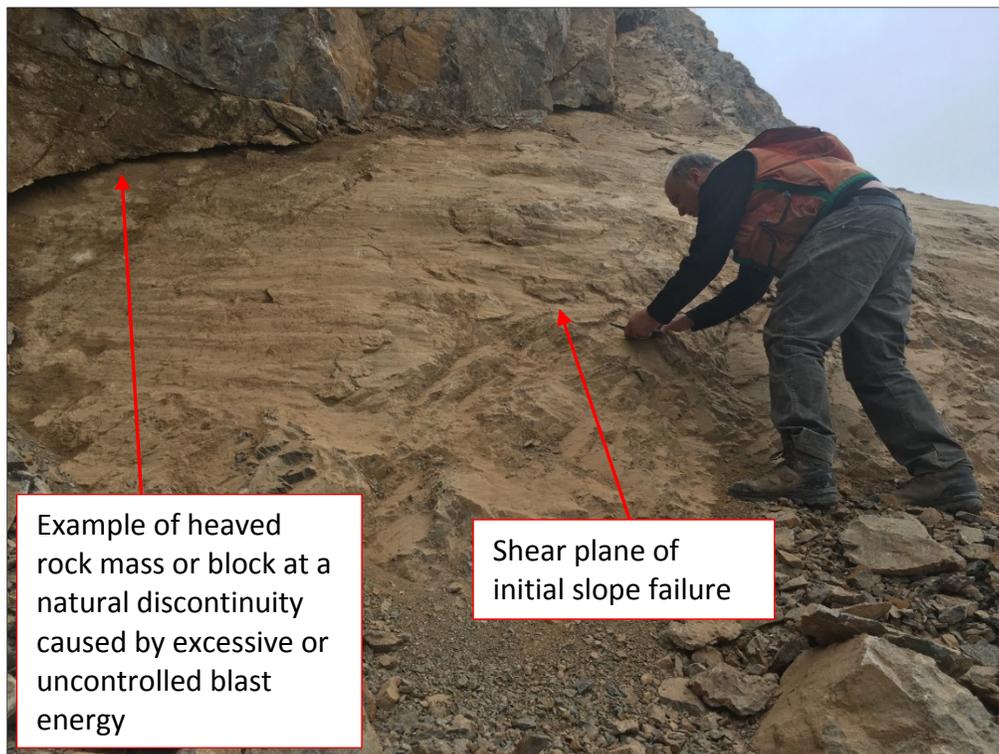
Figure 6 also shows the smoothness of the moderately undulating failure surface (rock joint roughness profile/joint roughness coefficient [JRC]=14-16). The roughness of the discontinuity interface helps prevent the sliding of the rock block downward, as the roughness creates a mechanical interlock between the rock masses. However, as shown in Figure 6, if the rock mass is heaved and separated from the discontinuity, surface friction and mechanical interlock are greatly decreased.

Figure 6. Failure Plane (featuring PND geologist Paul Dzwonowski)

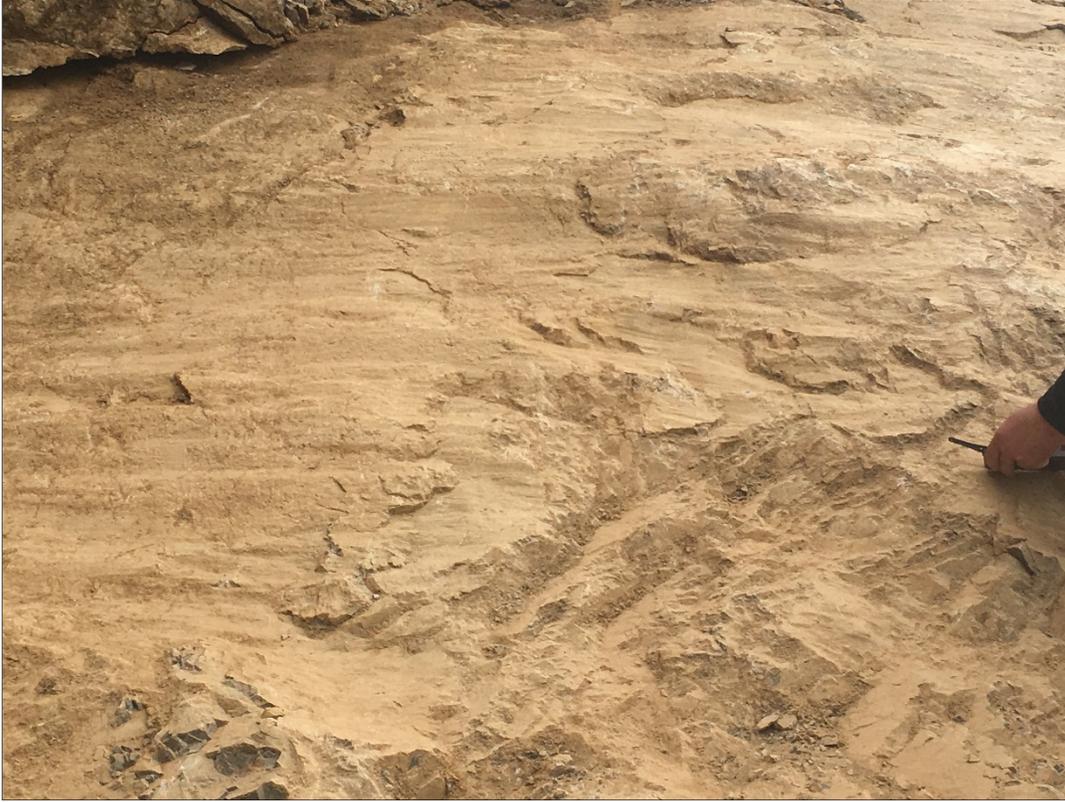
Figure 7. Failure Plane Rock Joint Roughness

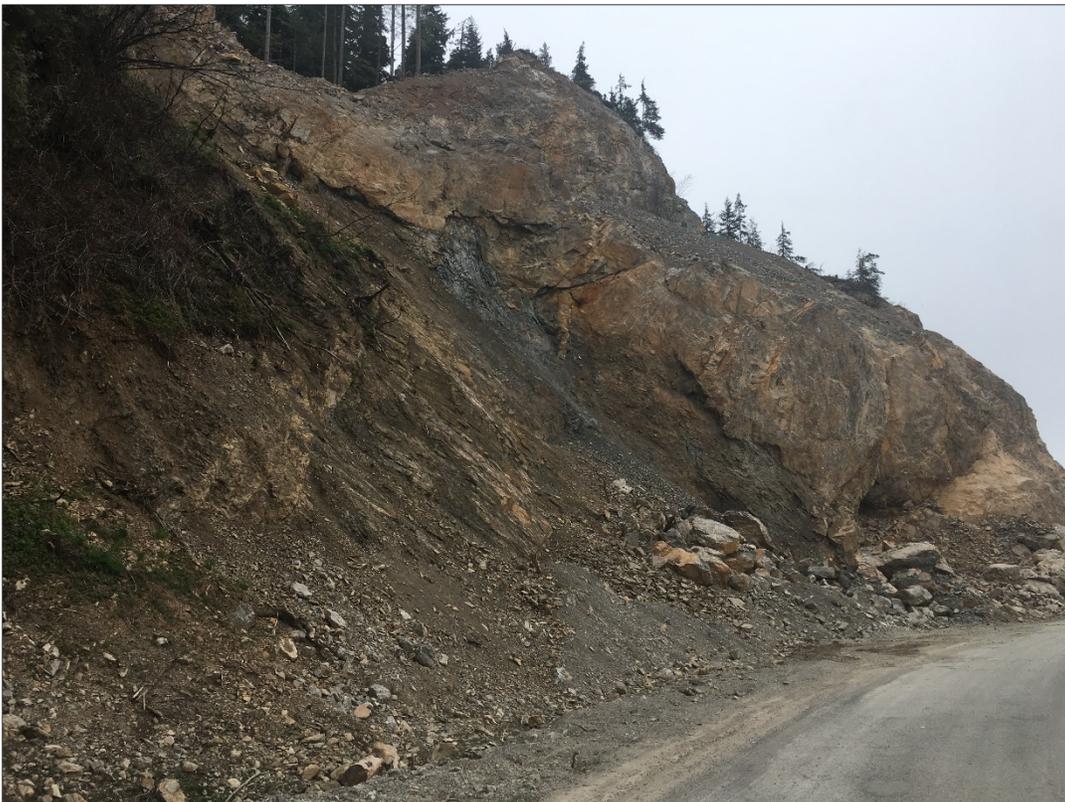
Figure 8. Dip of Failure Plane

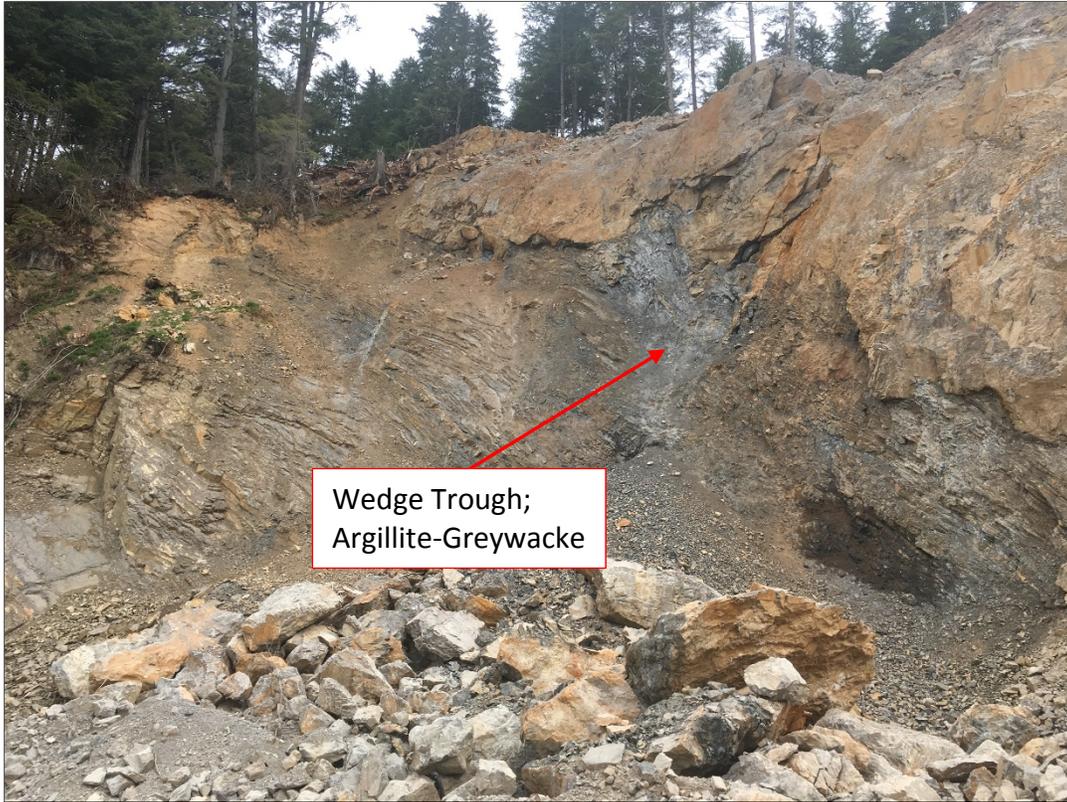
Figure 9. Wedge Failure

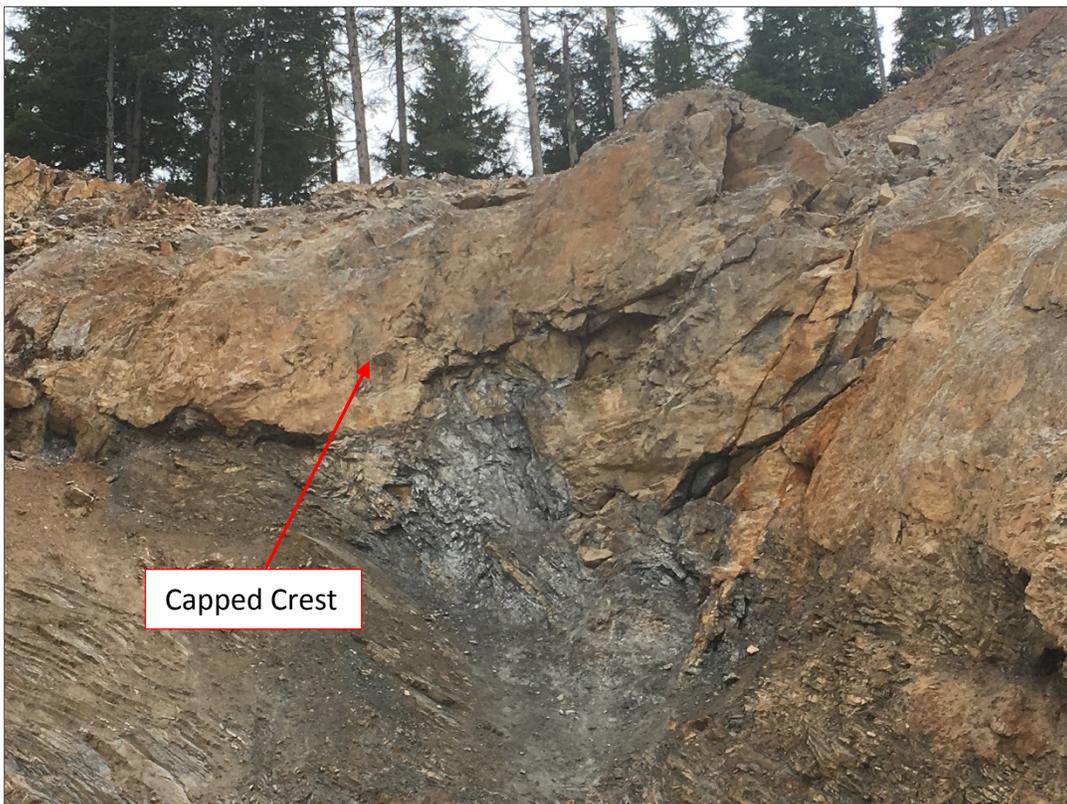
Figure 10. Limestone Cap-Crest

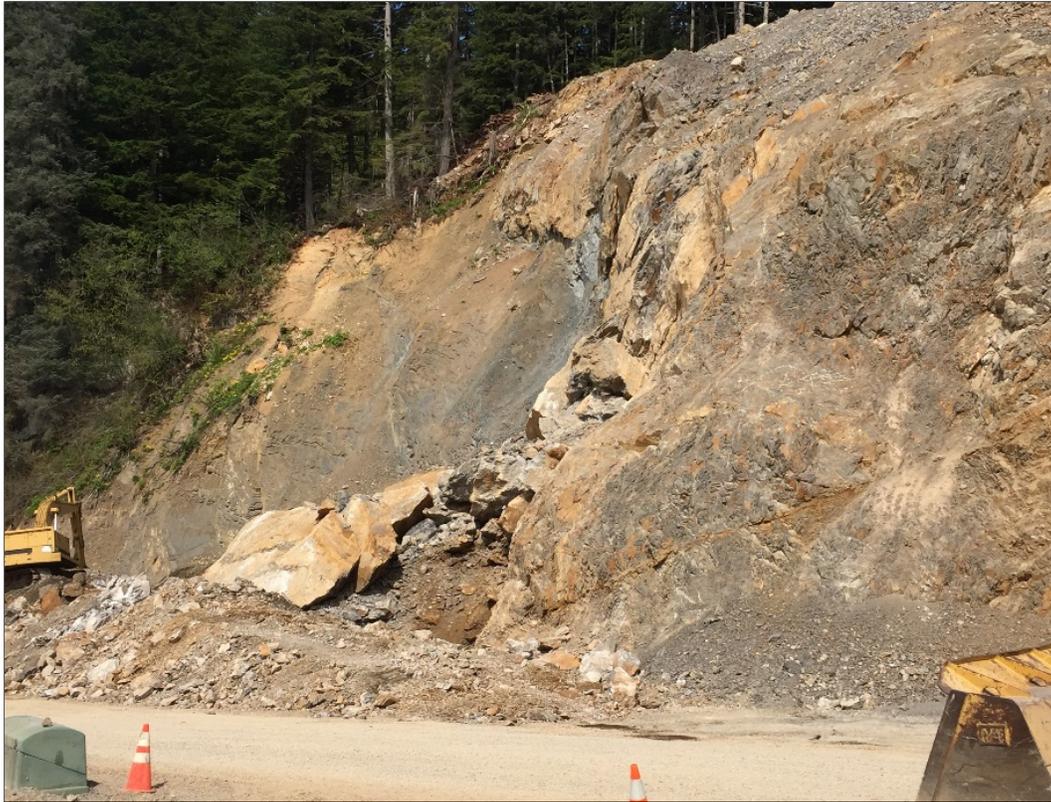
Figure 11. Slope Failure; May 8, 2017

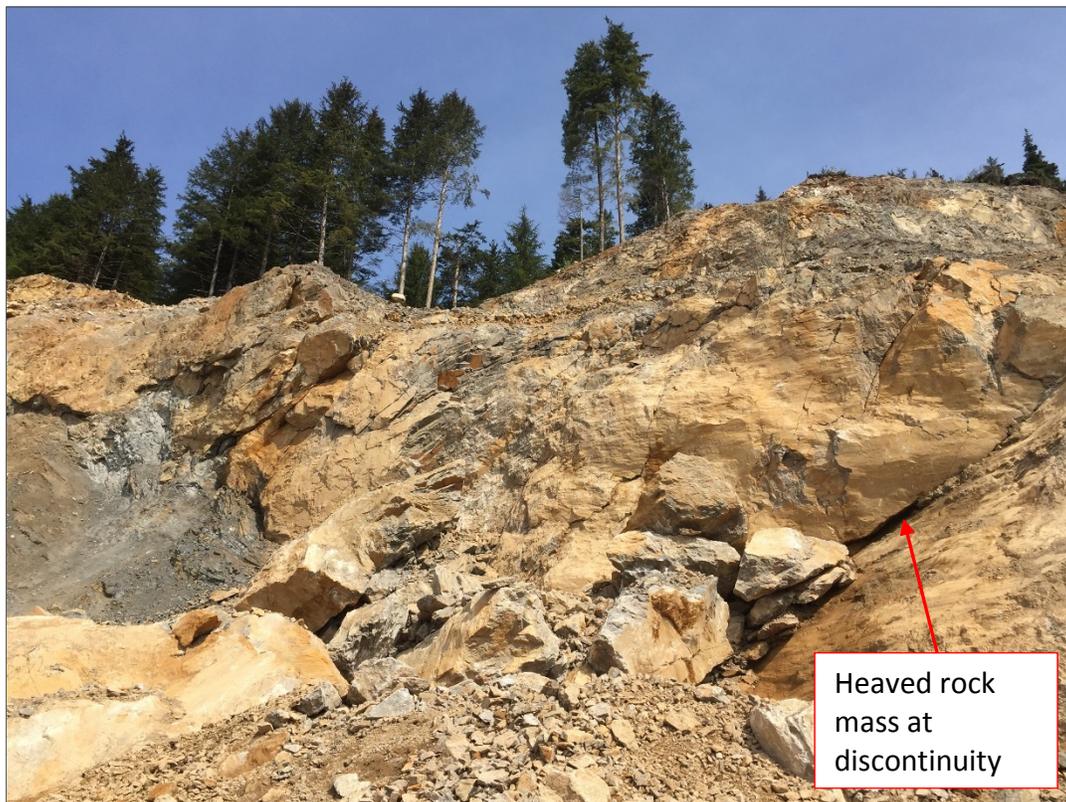
Figure 12. Slope Failure with Potential Remaining Failure Wedge; May 8, 2017

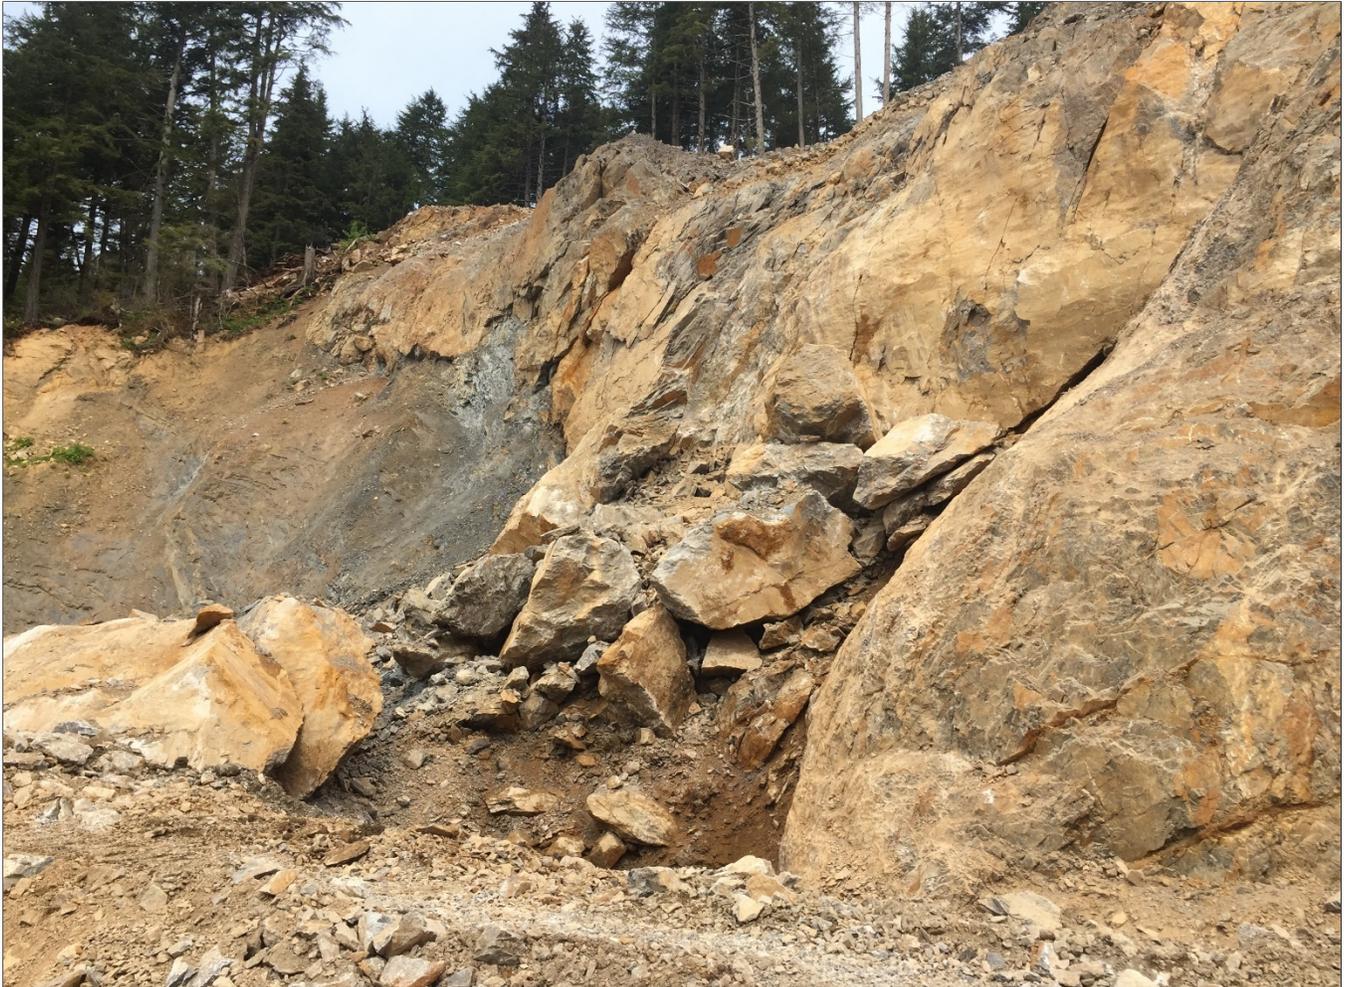
Figure 13. Slope Failure with Potential Remaining Failure Wedge; May 8, 2017

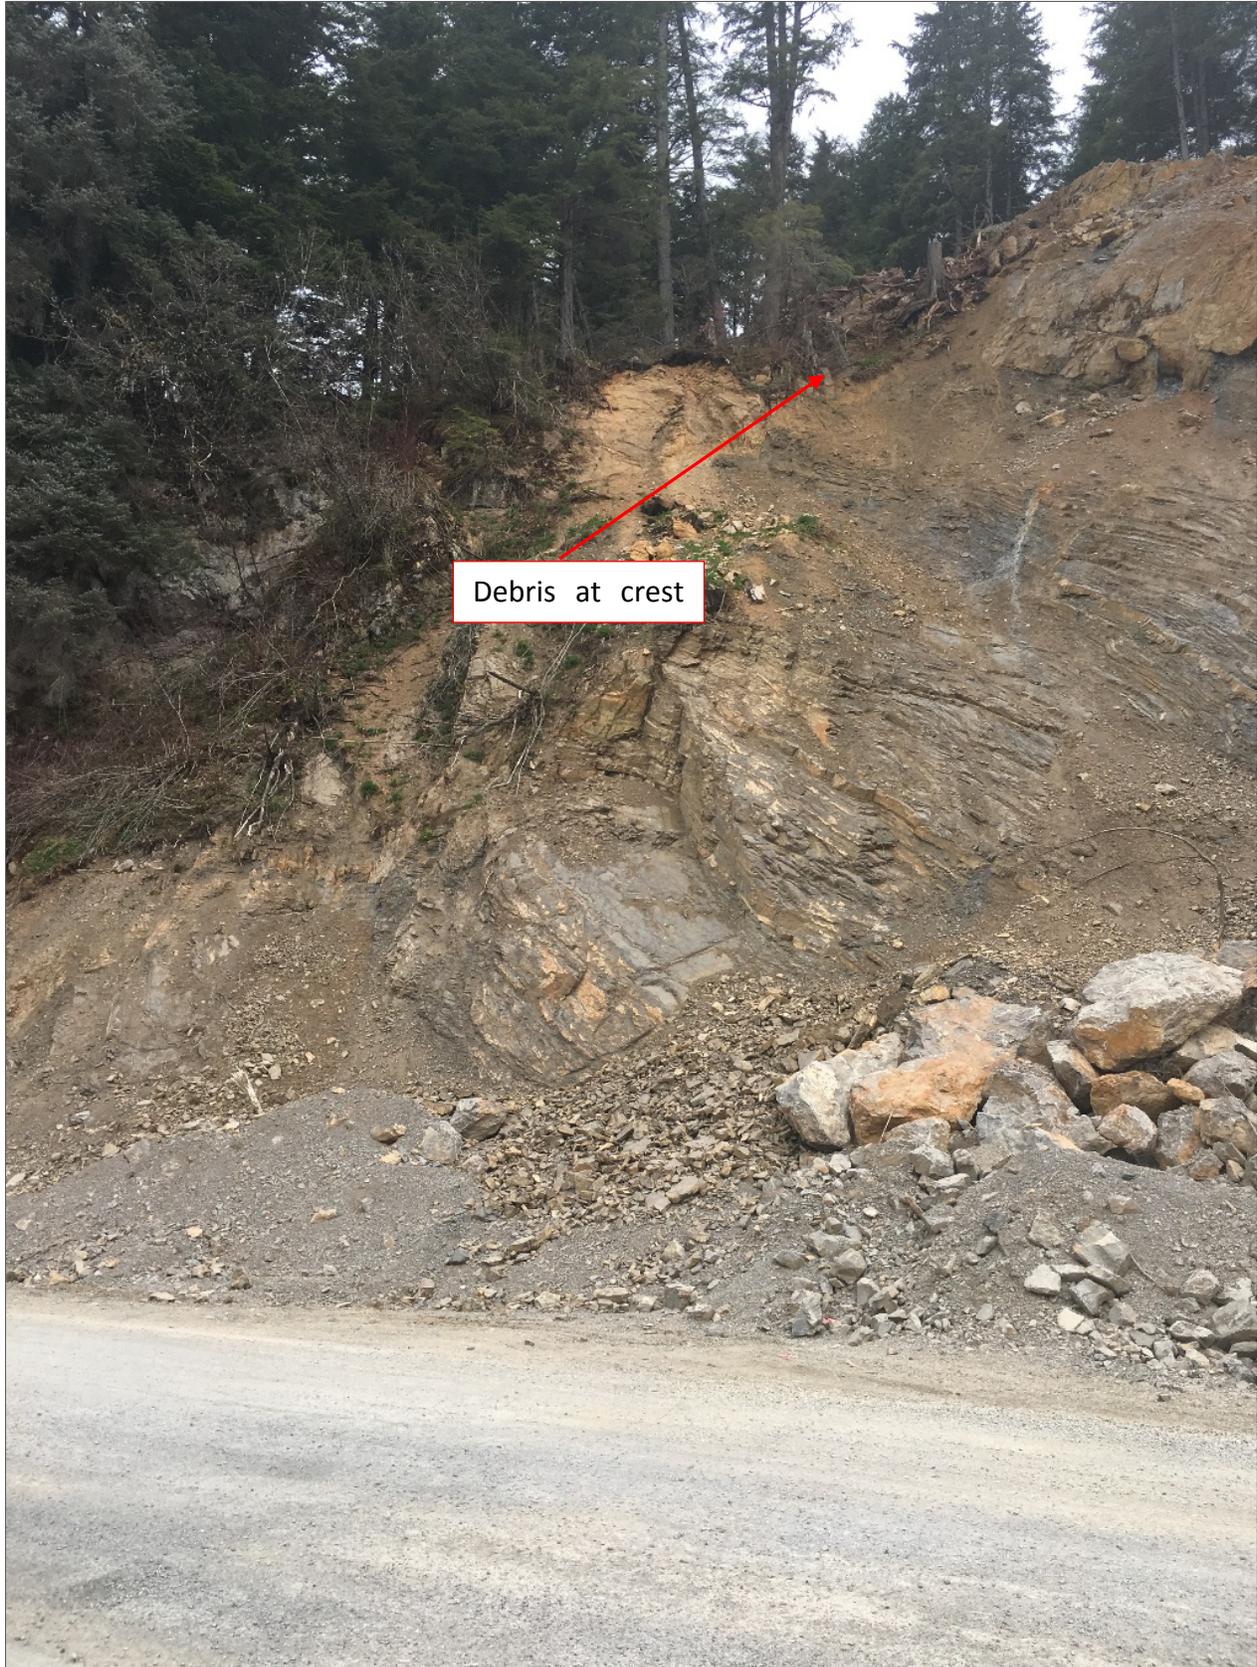
Figure 14 and Figure 15 show organic matter from clearing tasks stacked at the crests of Sections 1C and 2A. Below each crest are smooth, 40°-inclined (by visual observation) chutes which may contribute to a collapse or sloughing of the overburden above.

Figure 14. Potential Debris Flow at Crest

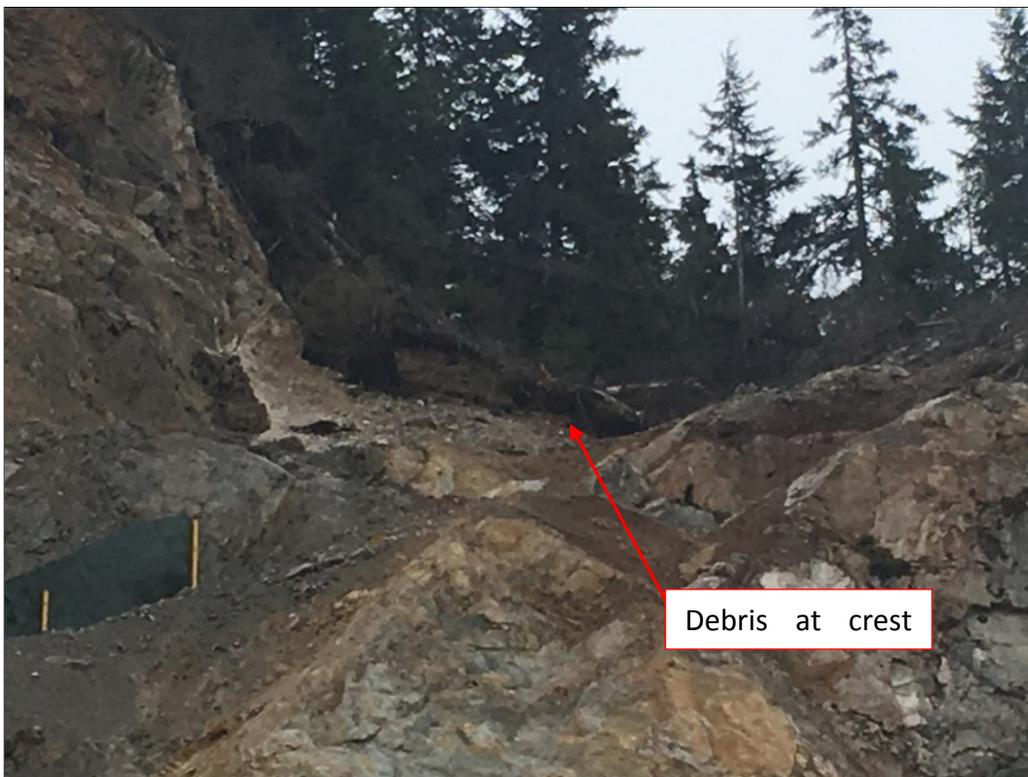
Figure 16. Potential Debris Failure at Crest

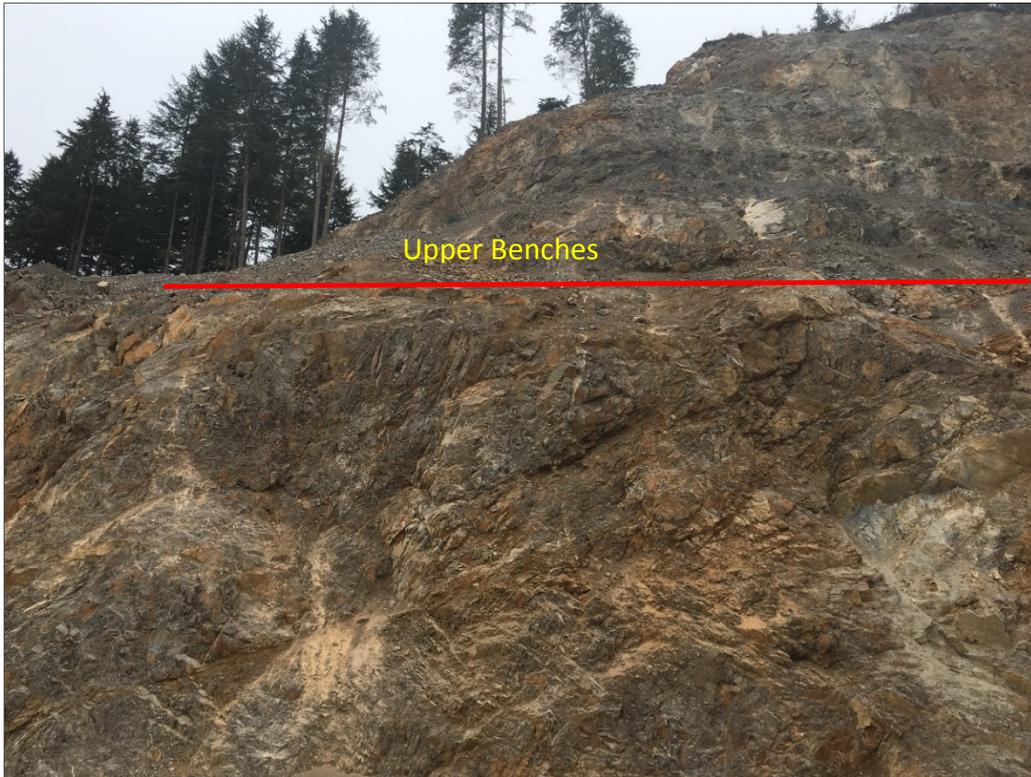
Figure 17. Upper Benches and Blocky Mass Rock of Undisturbed (blast) Rock Face

It is assumed that the lower backwall (Figure 17) is stable and will require no additional remediation. However, excessive overbreak and bench debris on the upper benches (Figure 17) may contribute to future and continual raveling, spalling, and littering of rock onto the adjacent road. It is recommended that a rock catchment fence be installed along the length of Section 3. The location of the catchment fence, at the road elevation or along the top of the first bench (bench closest to road elevation) would require a rockfall analysis to determine rock trajectory. A catchment fence along the top of the first bench would have greater initial costs but reduce maintenance costs long term. It may also be more aesthetically desirable than a catchment fence at the road elevation.

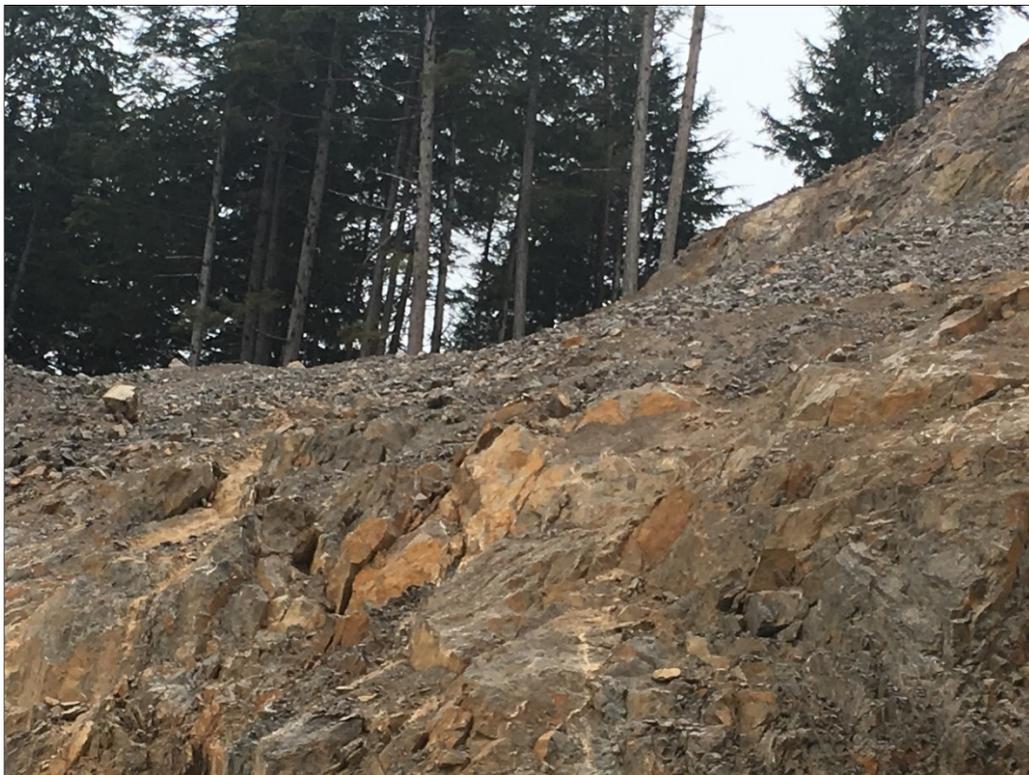
Figure 18 shows excessive blast debris and scree left on benches and at bench crests. Many of the bench sections appear to be of less than optimal width to provide an adequate rockfall catchment, and also dip downward toward the road further inhibiting rockfall protection effectiveness. Excessive debris may contribute to continued rock littering of the adjacent road below.

Figure 18. Potential Nuisance Rock Littering from Blast Debris

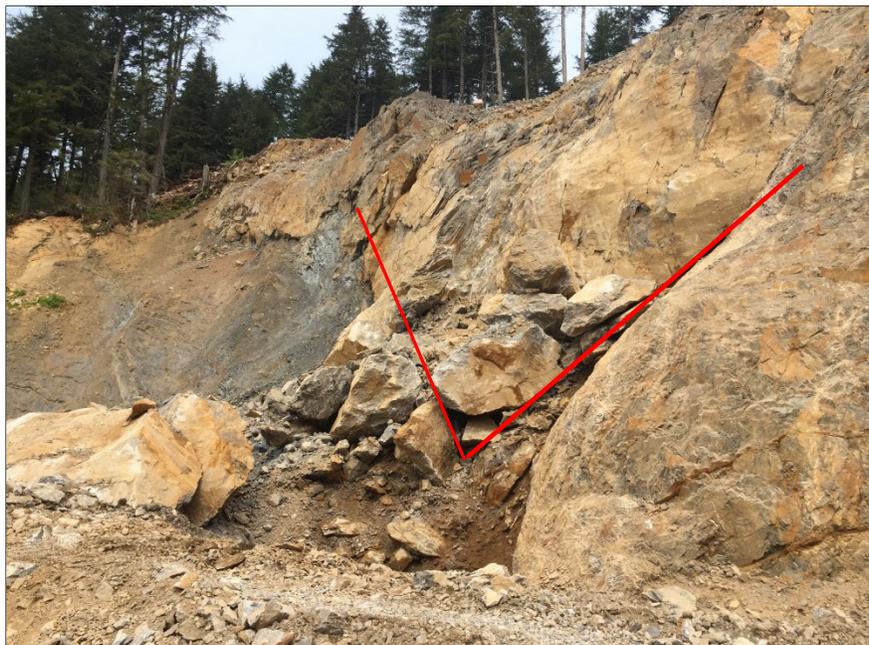
Figure 19. Remaining Wedge

The remaining potential rock slope wedge failure (Figure 19) could be mitigated by drilling and blasting from above (road access appears to be available to the first bench) or possibly using an excavator-mounted hydraulic rock breaker to bring down the remainder of the wedge from below. Rock bolting is not recommended as the rock mass is too disturbed for a high probability of success. Also, imparted energy from the rock anchor drilling operation may cause the wedge to fail and create a severe safety hazard for drilling personnel and equipment.

A possible economical, albeit perhaps less aesthetic remediation would be to use the failed rock debris/boulders to construct a gravity revetment at the base of the wedge. A kinematic analysis would be required to assess this option to determine whether enough resistive force (weight) could be developed in the revetment to counter the driving force of the remaining wedge.
